## Audit of Ambient Air Monitoring Stations for the Sistema de Monitoreo Atmosférico de la Ciudad de México

**Dirección de Monitoreo Atmosférico  
Dirección General de Gestión de la Calidad del Aire  
Secretaría del Medio Ambiente  
Ciudad de México**

Submitted by:  
**Eric Anderson  
EPA Systems, LLC  
Austin, Texas  
Roberto Toquero  
Bettel Ecológica  
México, D. F.**

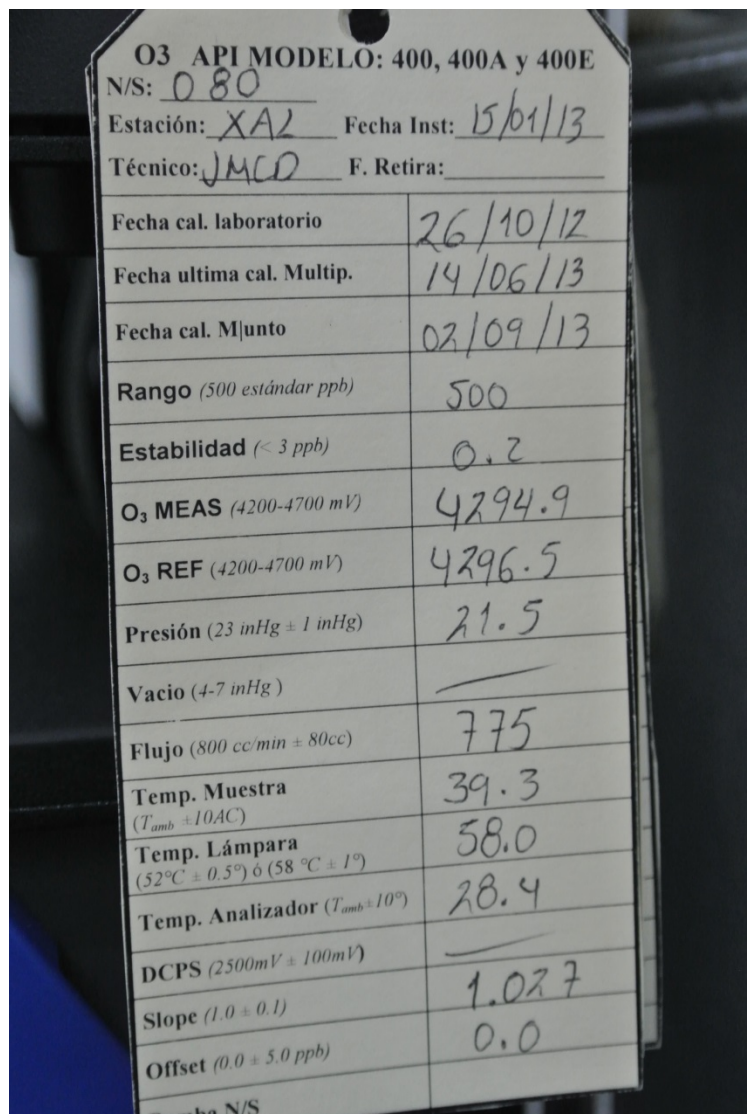
**Figure 3-1. Photo of Instrument Information Tag**

There were a number of "best practices" that the network uses to help ensure quality. There are Standard Operating Procedures (SOPs) for each analyzer make and model that can be referred to for new operators or used for training. During each quarterly multipoint calibration, instrument diagnostics information and instrument performance parameters are recorded for each instrument and written on a heavy paper tag that is affixed to each analyzer. A photograph of one of these tags is shown in Figure 3-1. Each time an operator goes to a site to perform calibrations or other maintenance activities, the current operational parameters are reviewed based on the values listed on each instrument's performance tag. Any significant changes from the values on the tag may be indicative of a possible instrument malfunction or degraded performance. As this information is typically available (depending on how long an individual instrument has been at a site) for a given instrument for at least one year if not much longer, these tags allow an operator to very quickly determine if the current instrument performance has degraded (such as PMT voltage) since last multipoint calibration.

O3 API MODELO: 400, 400A y 400E	
N/S: 080	
Estación: XA2	Fecha Inst: 15/01/13
Técnico: JMCO	F. Retira:
Fecha cal. laboratorio	26/10/12
Fecha ultima cal. Multip.	14/06/13
Fecha cal. Mjuntó	02/09/13
Rango (500 estándar ppb)	500
Estabilidad (< 3 ppb)	0.2
O <sub>3</sub> MEAS (4200-4700 mV)	4294.9
O <sub>3</sub> REF (4200-4700 mV)	4296.5
Presión (23 inHg ± 1 inHg)	21.5
Vacio (4-7 inHg)	—
Flujo (800 cc/min ± 80cc)	775
Temp. Muestra (T <sub>amb</sub> ± 10AC)	39.3
Temp. Lámpara (52°C ± 0.5°) ó (58 °C ± 1°)	58.0
Temp. Analizador (T <sub>amb</sub> ± 10°)	28.4
DCPS (2500mV ± 100mV)	—
Slope (1.0 ± 0.1)	1.027
Offset (0.0 ± 5.0 ppb)	0.0
Bomba N/S

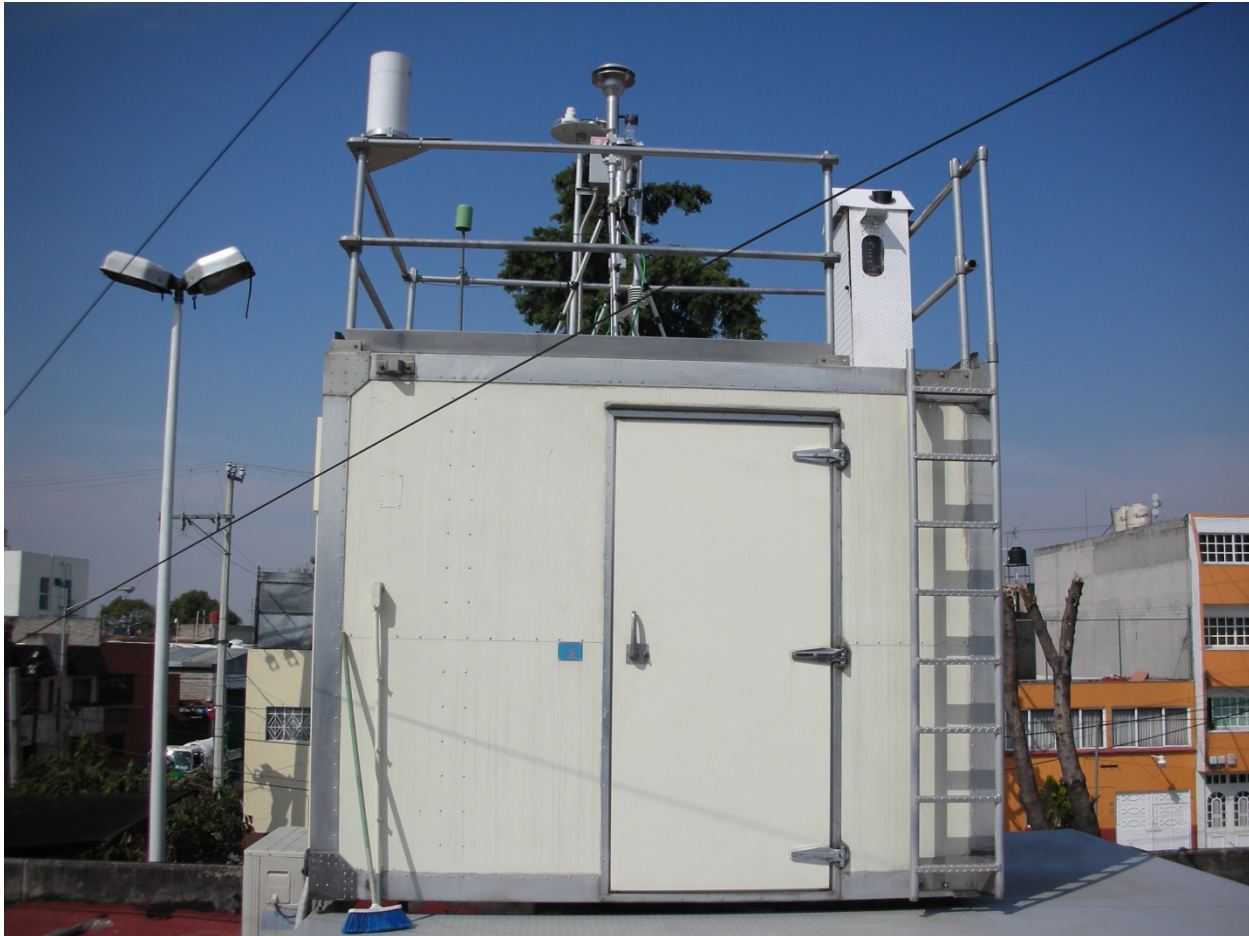
**Figure 3-2. Photo of SS1 Site on the Roof of the SIMAT Laboratory Facility**

This is a new site located on the roof of the SIMAT Laboratory building. The site is housed in an Ekto Shelter and had been recently commissioned at the time of the audit. This is the headquarters of the Sistema de Monitoreo Atmosférico de la Ciudad de México and houses

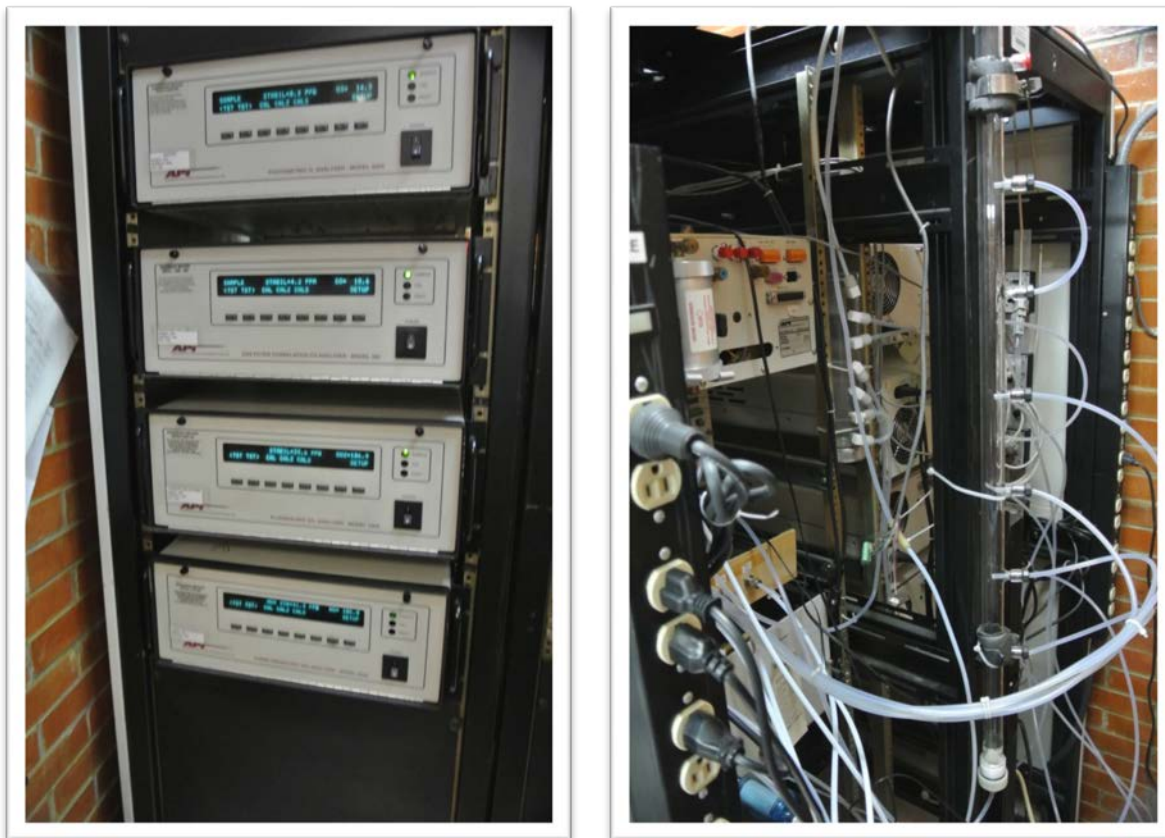
**Figure 3-3. Front and Back View of the SIMIT Laboratory Reference Analyzers**

This is the headquarters of the Sistema de Monitoreo Atmosférico de la Ciudad de México and houses some of the network's reference analyzers. These units are not typically used to monitor ambient air but rather are used to do comparisons to field analyzers.

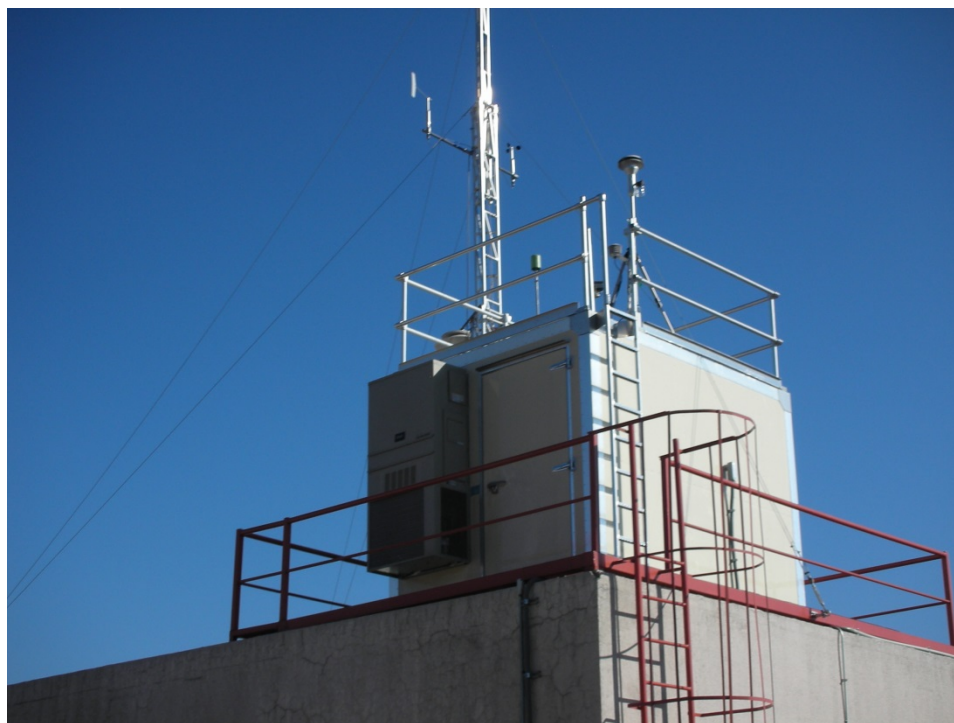
**Figure 3-4. Photo of AJM Ambient Site Shelter on Roof of Hospital**

Description: This station is located on the fourth floor roof of a new hospital. The instruments are housed in an Ekto Shelter with sample inlet approximately 25 m above ground level. The "green" roof is covered in plant material to absorb rain fall, minimize runoff, and reduce heat buildup. This site is also equipped with a digital camera system that captures city-wide photo every 10 minutes for haze evaluation.

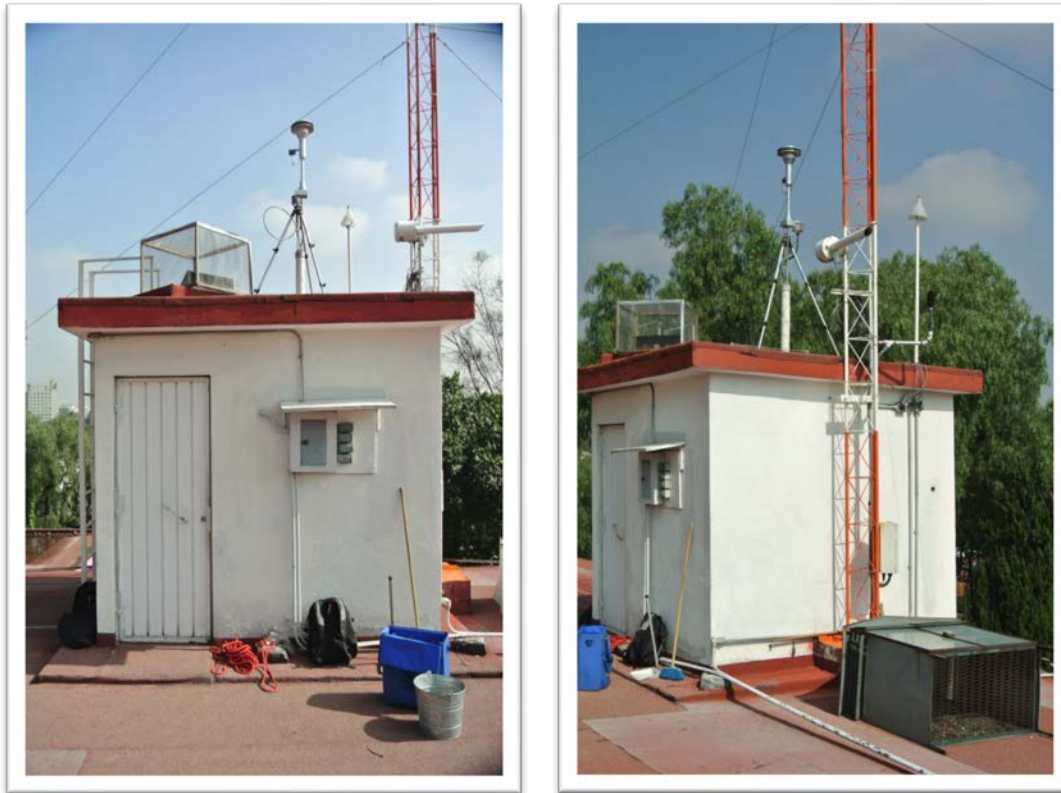
**Figure 3-6. Front and Side Views of the PED Site Shelter**

This station is in a high-income residential area at the southwest of Mexico City, housed in a shed on the top of the second floor of an elementary school. There are no major streets adjacent to the station. Sample inlet is 11 m above ground level.

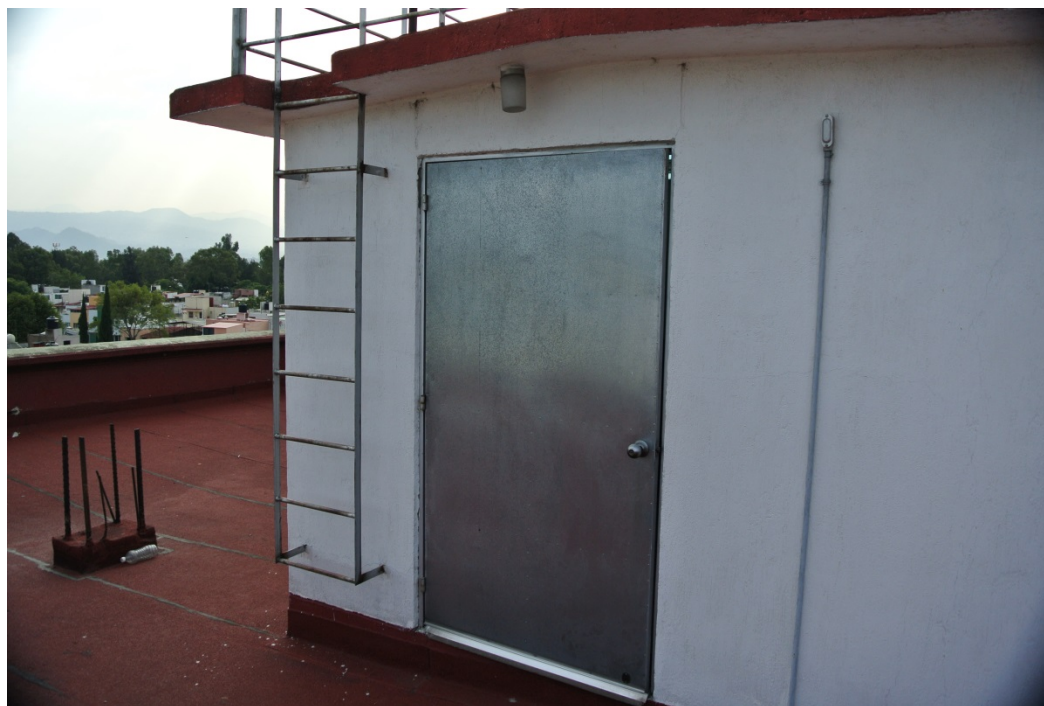
**Figure 3-7. Front View of UAX Shelter**

This station is located on the fourth floor roof of the science building at Universidad Autónoma Metropolitana Campus Xochimilco. The system was housed in a concrete building. The university is situated in a gated residential area with no major streets adjacent to the station. The sample inlet is approximately 20 m above ground level.

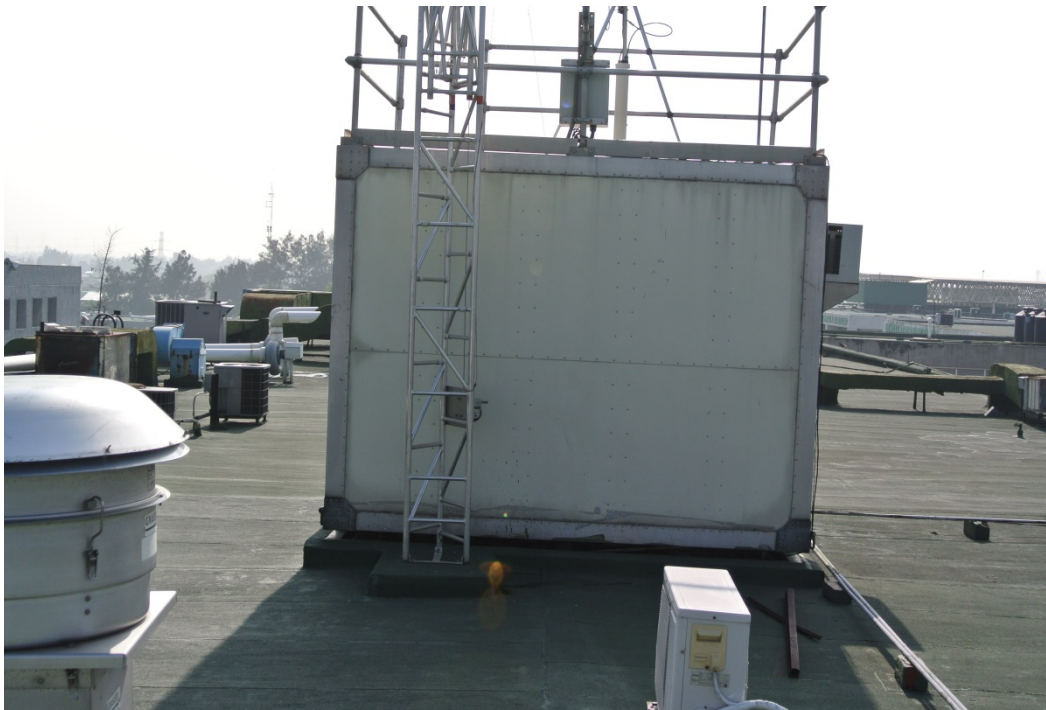
**Figure 3-9. Rear View of the UIZ Ekto Shelter**

This station is located on the top of the third floor building at Universidad Autónoma Metropolitana Campus Iztapalapa and housed in an Ekto Shelter. There are no major streets adjacent to the station. Sample inlet is approximately 18 m above ground level.

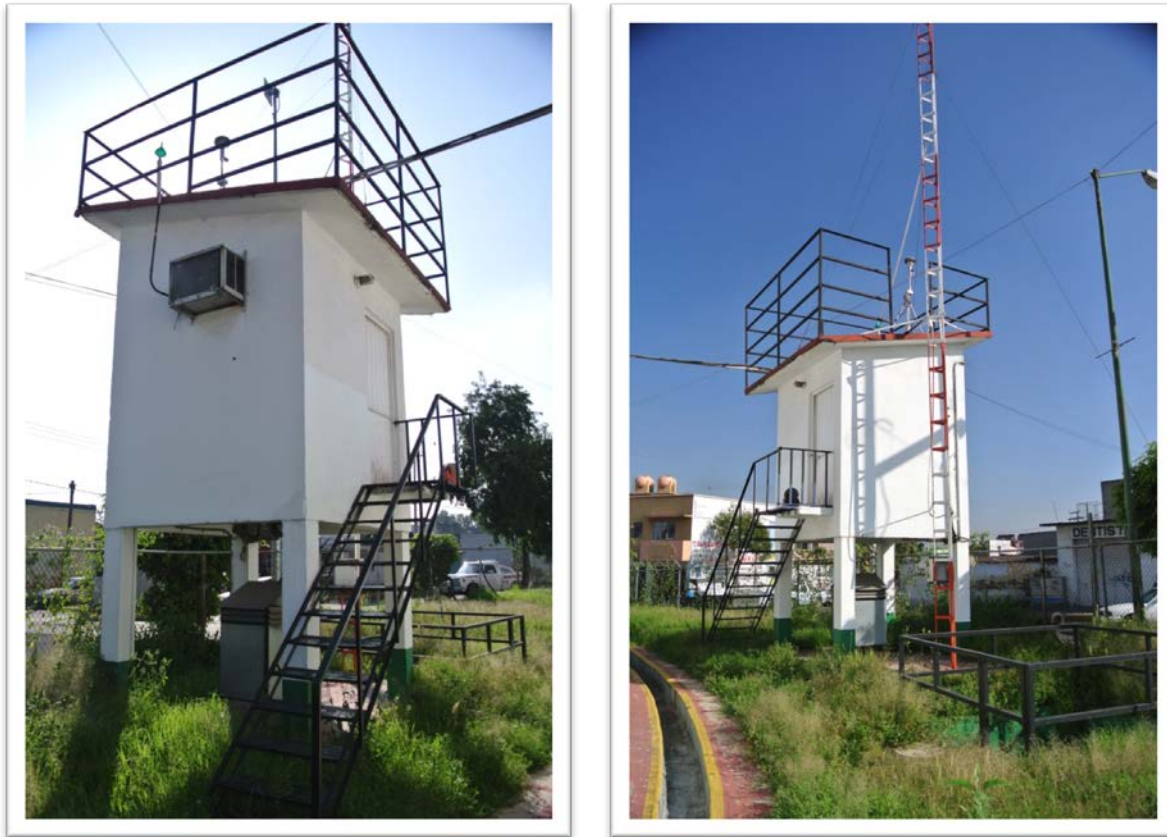
**Figure 3-11. Side Views of the TLA Site**

This station is located in a shed on the top of a 2 meter platform in the northwest of the city in the municipality of Tlalnepantla, Estado de México. This site is located at a municipal water facility in a generally residential neighborhood. There are no major streets adjacent to this site. This site is downwind from a major industrial area located north of the site. Sample Inlet is approximately 6.8 m above ground level.

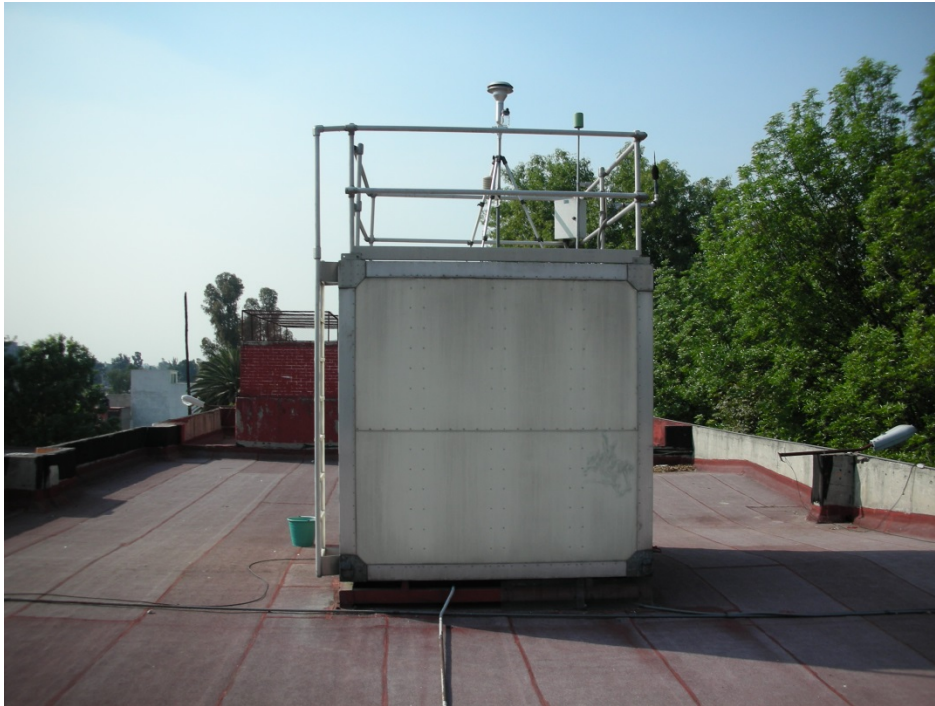
**Figure 3-12. Side View of Ekto Shelter at SJA Site, Looking West**

This site was located on the third floor roof of an elementary school approximately 15 meters above ground level with monitoring equipment housed in an Ekto shelter. This site has a number a large trees higher than the roof line of the building and about even with the shelter’s inlet that could pose some air flow restrictions. The audit results showed that all of the parameters {O<sub>3</sub> (4.6%), NO (-7.0%), NO<sub>x</sub> (-1.3%), SO<sub>2</sub> (1.1%), and CO (1.8%)} were well within the audit objective of ± 15%. In addition, the GPT showed a NO<sub>2</sub> convertor efficiency of 100.4%. Audit results for each of the analyzers at this site are shown in Tables 3-46 to 3-51. Photos of the site are shown in Figures 3-12 and 3-13.

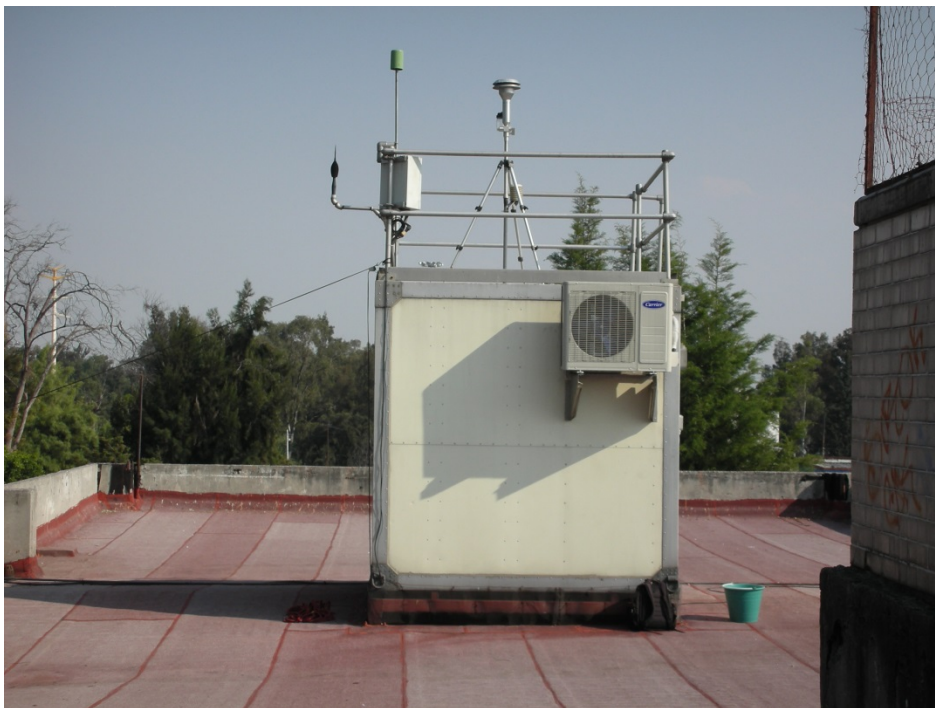
**Figure 3-13. Side View of Ekto Shelter at SJA site, Looking East**

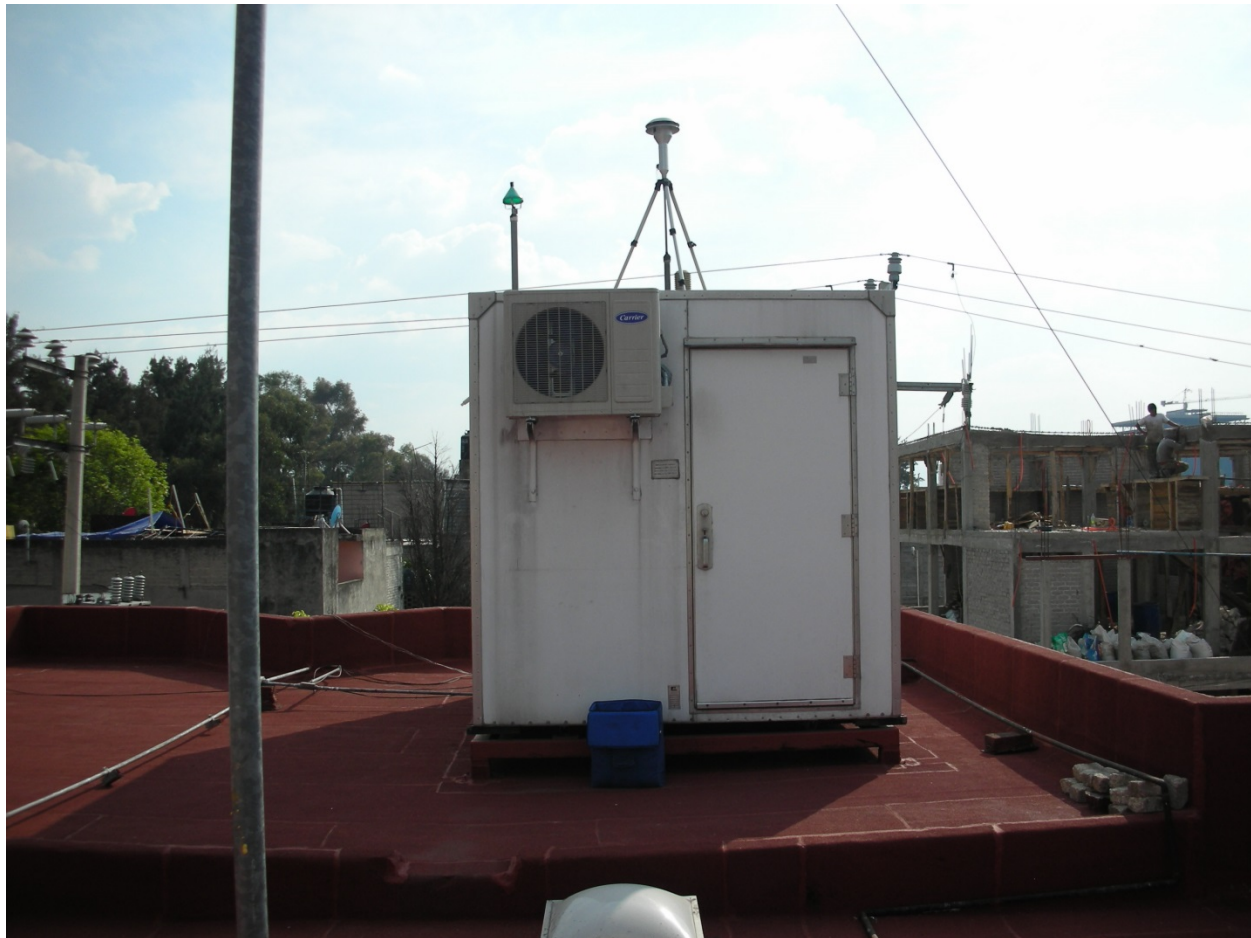
**Figure 3-15. Front View of IZT Shelter**

The IZT site is located on the second floor roof of a health care center in a residential area. The center is surrounded by 2 – 3 story homes with additional construction across the street. The audit results showed that all of the parameters {O<sub>3</sub> (2.6%), NO (-2.9%), NO<sub>x</sub> (0.0%), SO<sub>2</sub> (-0.4%), CO (3.9%)} were well within the audit objective of ± 15%. The GPT showed a NO<sub>2</sub> convertor efficiency of 101.3%. Sample results for each of the analyzers at this site are shown in Tables 3-58 to 3-63. A photo of this site is shown in Figures 3-15.
